Florida Bay Current Conditions: Another Perfect Storm?

Fred H. Sklar, Ph.D., Section Administrator
Everglades Systems Assessment
September 3, 2015

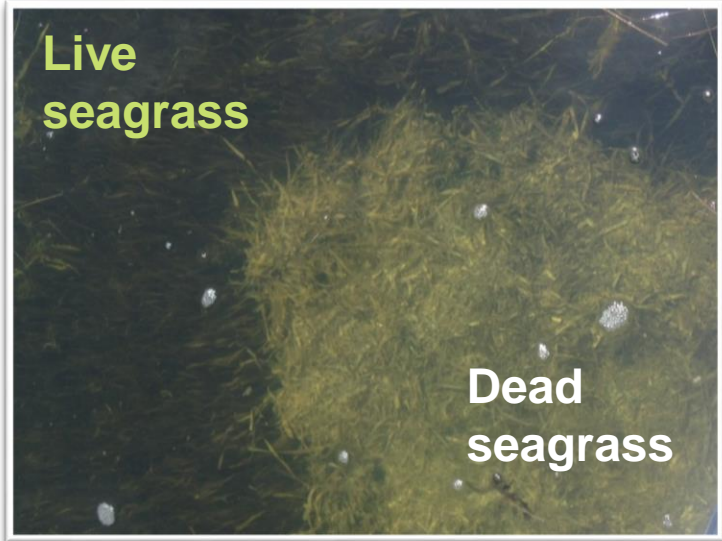
- Distinct patches of dead seagrass
- Little to no SAV in the mangrove creeks

Large floating rafts of dead seagrass - not typical in the bay

July 2015

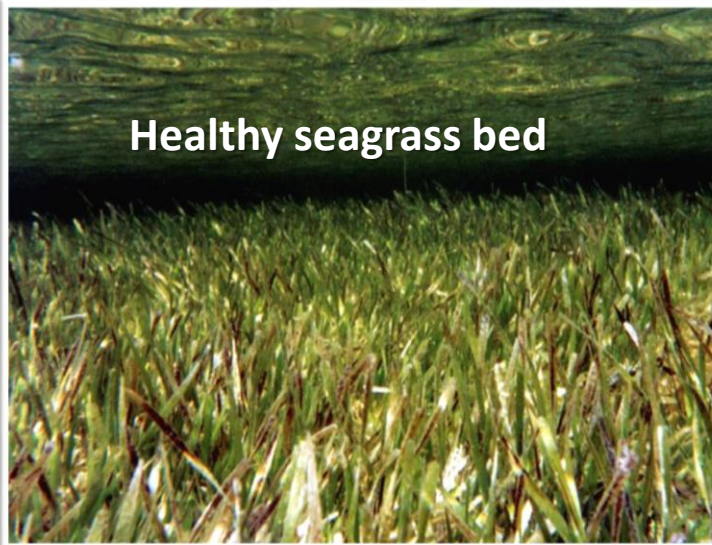
Healthy seagrass bed

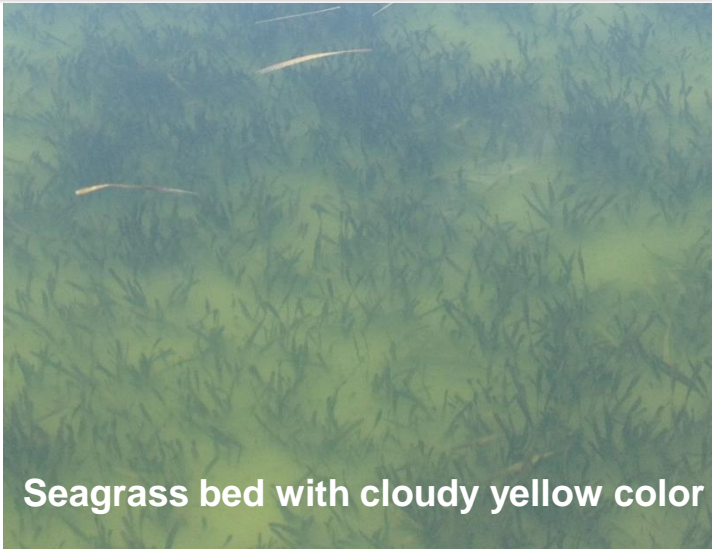
Seagrass bed with cloudy yellow color

Central
Florida Bay
“yellow fog”
is currently
under
investigation

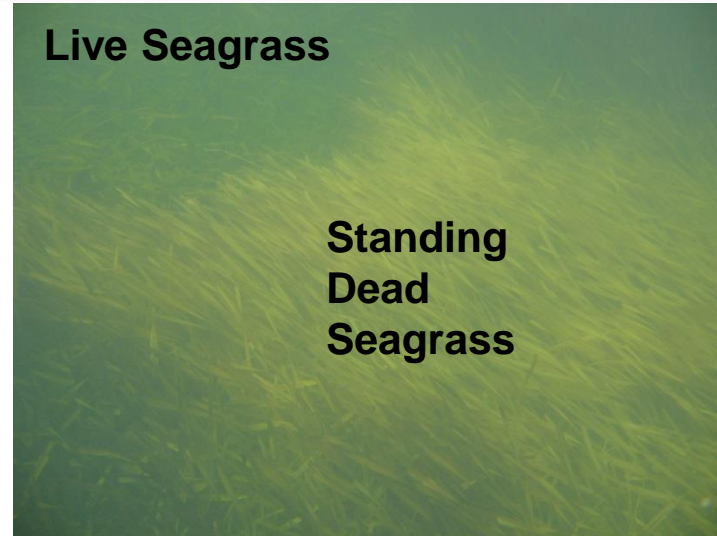
Live Seagrass

Standing
Dead
Seagrass

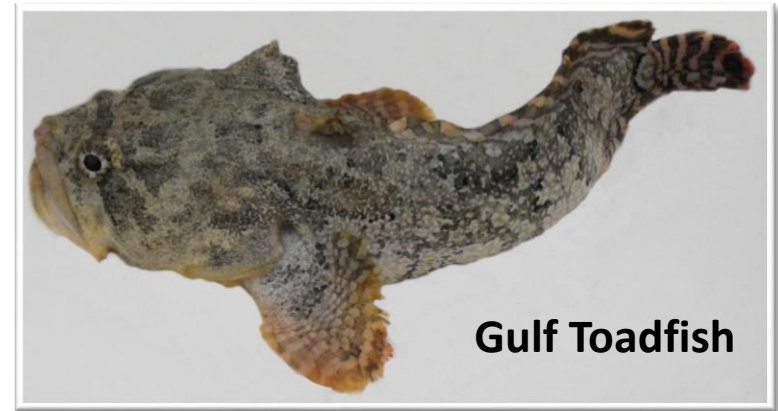
Low Dissolved Oxygen in Central Bay

Toadfish are bottom dwelling. The Toadfish kill in central Florida Bay, observed on July 22, was likely due to hypoxia.
